VIOLET CROWN AERIAL :: ROOF ASSESSMENT

SAMPLE REPORT

# Roof Condition Report

Two story motel  
Austin, TX

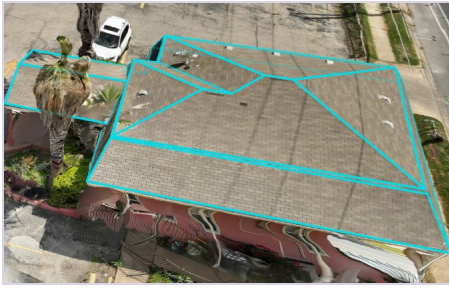
**Fig. 1** Office building. South and west slopes show uniform granule loss.

| PRIORITY | WHAT WE FOUND | RECOMMENDATION | WHEN |
|---|---|---|---|
| MONITOR | <b>Granule loss from age and sun</b><br>South and west slopes on both buildings. Fig. 1 | No repair needed now. Budget for replacement in 5 to 7 years. | Next visit |

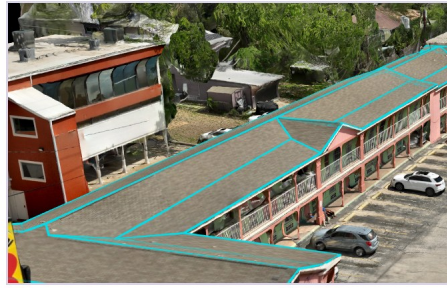
**Fig. 2** Main building, inside corner of the L. Debris collects in the valley.

| PRIORITY | WHAT WE FOUND | RECOMMENDATION | WHEN |
|---|---|---|---|
| PRIORITY | <b>Debris holding water in the valleys</b><br>Inside corner of the L, where the two wings meet. Fig. 2 | Clear the valleys and gutters, then check the shingles beneath for wear. | 90 days |

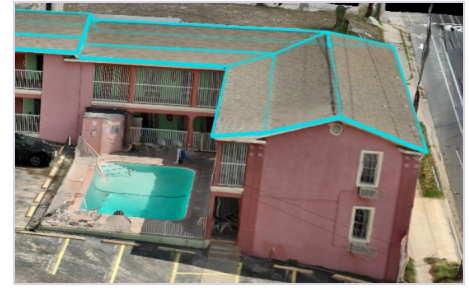
**Fig. 3** Main building, east wing. Lifted caps along the hip ridges.

| PRIORITY | WHAT WE FOUND | RECOMMENDATION | WHEN |
|---|---|---|---|
| PRIORITY | <b>Lifted and creased ridge caps</b><br>Hip ridges on the east wing of the main building, about 30 linear ft. Fig. 3 | Re-secure or replace the caps and seal the nail heads. | 90 days |
